Manhole Inspection Summary

Manhole # S51U1_006MH

Insp Date: **5/30/08 1:47 PM**

Location Address: **3100 Vera St.**

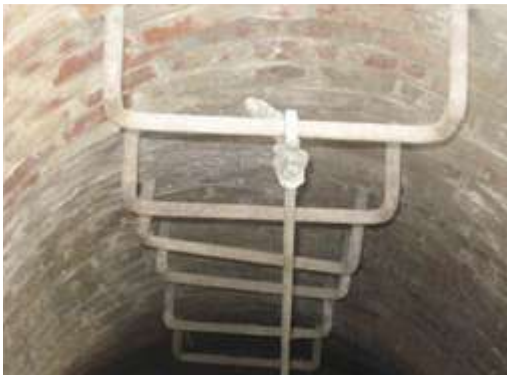
Steps Count: **6** Missing: **0** ☐ Corroded

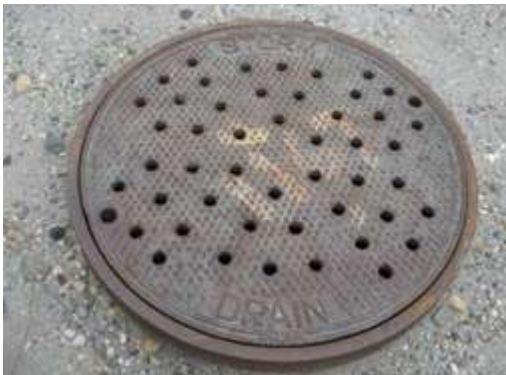
Cover Shape: **Circular** Diameter: **30** (in.) Length: (in.) Dist A/B Grade: **3** (in.)

Type: **Stormwater** Condition: **Sound** Cover Material: **Cast Iron**

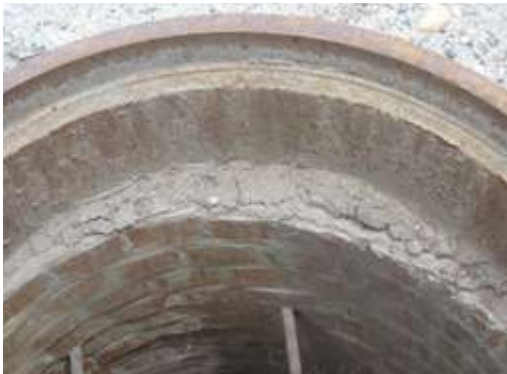
Defect 1

Frame Offset: **2** (in.) Condition: ☒ Sound ☐ Cracked ☐ Leaks

Frame offset

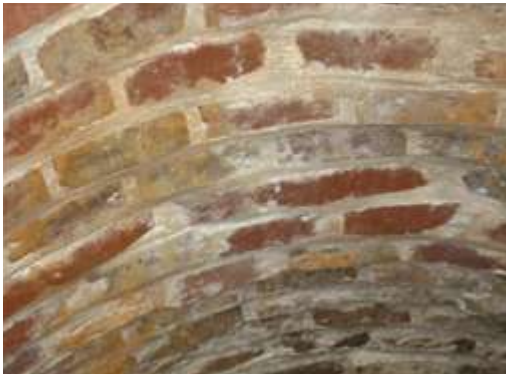
Defect 2

Infiltration: ☐ None ☐ Joint ☐ Cracks ☐ Mortar ☐ Roots ☒ **Wall**

Infiltration

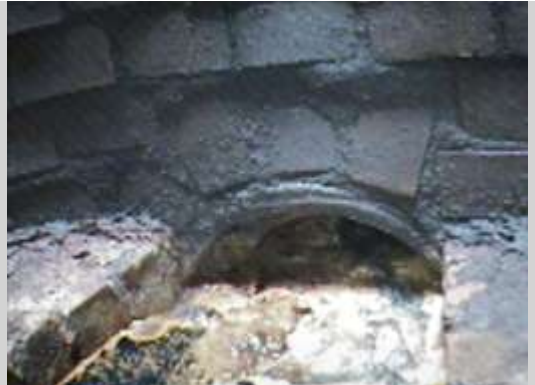
12 O'Clock Outflow

8 in. Circular Gravity Sewer
Pipe Out @ 12 O'Clock

Pipe Height: **9.6** (in.) Rod and Bar (Angled)
Pipe Material: **Clay** ☐ Pipe Lined
Invert Depth: **12.40** (ft.) Flow Characteristics: **Slow**
Deposits: ☐ None ☐ Mud ☒ **Sludge** ☐ Debris ☐ Grease
Silt Depth: **4** (in.) Deposits Extent: **Medium**
Infiltration: **None** Pipe Seal Cond: **Sound**

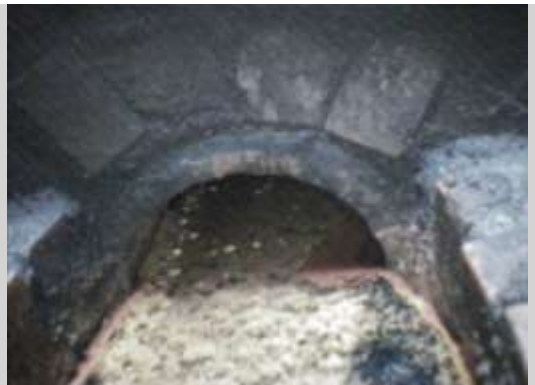
5 O'Clock Inflow

8 in. Circular Gravity Sewer
Pipe In @ 5 O'Clock

Pipe Height: **8.4** (in.) Rod and Bar (Angled)
Pipe Material: **Clay** ☐ Pipe Lined
Invert Depth: **11.96** (ft.) Flow Characteristics: **Slow**
Deposits: ☐ None ☐ Mud ☒ **Sludge** ☐ Debris ☐ Grease
Silt Depth: **2** (in.) Deposits Extent: **Light**
Infiltration: **None** Pipe Seal Cond: **Sound**
